Monitoring Data Record

Project Title: R-2417BA (Sites 14 and 22) COE Action ID: 2002-2-0899
 Stream Name: n/a DWQ Numbers: 001432
 City, County and other Location Information: Lee County, US 421-NC 87 Sanford Bypass from East of US 1-15-501 to East of SR 1521
 Date Construction Completed: Site 14 (May 2003) & Site 22 (April 2004)
 Monitoring Quarter: (1) of 8
 Ecoregion: _____ 8 digit HUC unit: 03030004
 USGS Quad Name and Coordinates: _____

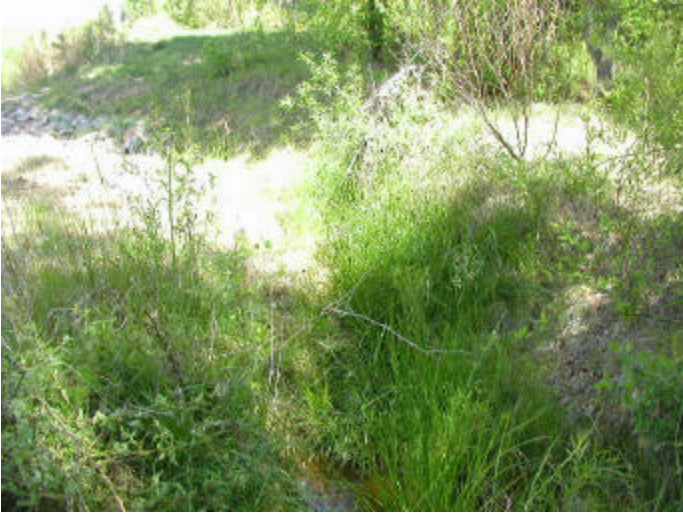
Photo 1

Site 14 stream relocation at Sta. 133+90 LT. is stabilized for the 1st quarter of monitoring.
